Strategic Housing Development at  
North Wall Quay, Co. Dublin

Quality Audit

**Document Ref:** P20-096-UQA-GEN-RP-001

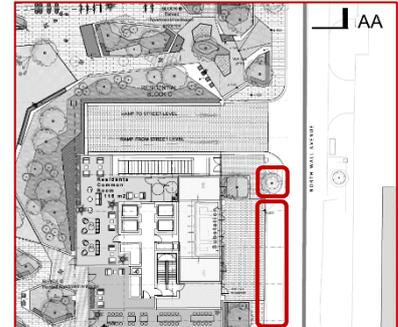
Summary: *Insufficient inter-visibility between drivers exiting the basement access ramp and pedestrians/drivers on North Wall Avenue may lead to side-on and vehicle/pedestrian collisions.*

A tree is indicated to the south of the basement carpark access ramp and may reduce inter-visibility between drivers exiting the basement carpark and pedestrians/drivers on North Wall Avenue. Insufficient inter-visibility at the basement carpark access may lead to drivers entering North Wall Avenue, or crossing the footway, when it is unsafe to do so, leading to side-on or vehicle/pedestrian collisions.

Additionally, inset parallel parking bays on North Wall Avenue may further reduce a driver’s visibility when exiting the basement carpark, leading to side-on collisions.

Remove/relocate the tree indicated to the south of the basement carpark access ramp and ensure visibility splays are not obstructed by vehicles parking within the inset parking bays.

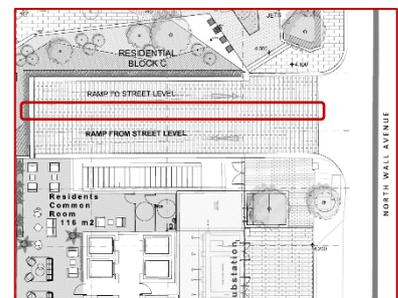
Summary: *The absence of lane separation on the basement carpark access ramp may result in low speed head-on collisions.*

The basement carpark access ramp does not include lane separation, such as road markings or physical measures. The absence of lane separation measures to clearly advise drivers of the entry and exit lanes may lead to drivers adopting a central position on the ramp, which may increase the risk of low speed head-on collisions with opposing vehicles.

Provide lane separation measures on all vehicle access ramps within the development.

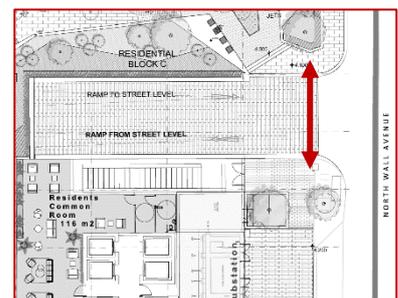
Summary: *No formal pedestrian crossing has been indicated at the development’s basement carpark access ramp, which could lead to slips, trips, and falls.*

A failure to provide dropped kerbs and tactile paving, or a continuous footway across the basement carpark access ramp, could result in mobility and visually impaired pedestrians on North Wall Avenue being unable to cross the access ramp safely and independently. This could result in slips, trips, or falls as these pedestrians attempt to descend the kerb.

Prioritise pedestrian movements across the development's access by providing a continuous footpath.

Alternatively, a formal uncontrolled pedestrian crossing, including dropped kerbs and tactile paving, should be provided at the development's basement carpark access.

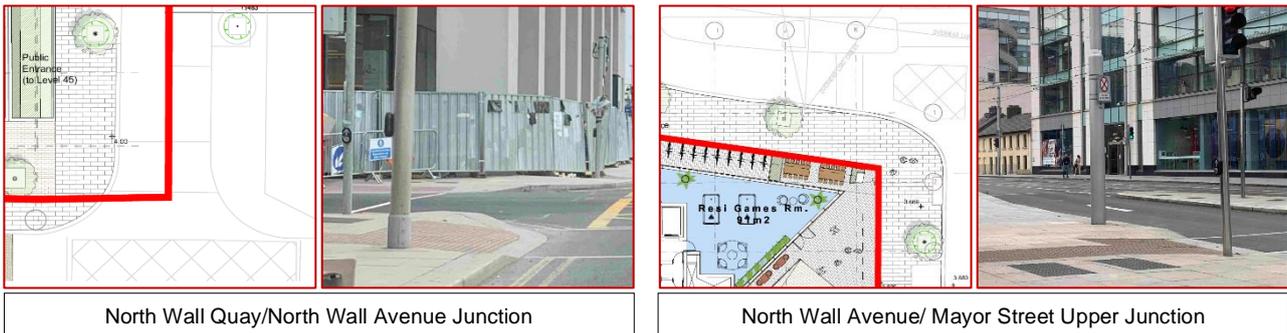
*Summary:* Removal of existing tactile paving may lead to visually impaired pedestrians being unable to locate the existing controlled pedestrian crossings or stepping into the carriageway without due care and attention, leading to vehicle/pedestrian collisions.

Existing tactile paving at the junction of North Wall Quay/North Wall Avenue and North Wall Avenue/ Mayor Street Upper is not indicated on the design drawings issued for Audit. Should the existing tactile paving be removed as part of the development, or fail to be modified to accommodate the development's footprint, there is a risk that visually impaired pedestrians may find it difficult to locate and correctly use the signalised pedestrian crossings, and enter the carriageway when it is unsafe to do so, leading to vehicle/pedestrian collisions.

The existing tactile paving should be incorporated within the development's design and be modified to seamlessly tie-in with the development's footprint (e.g. tactile stem extended to the new back of footway).

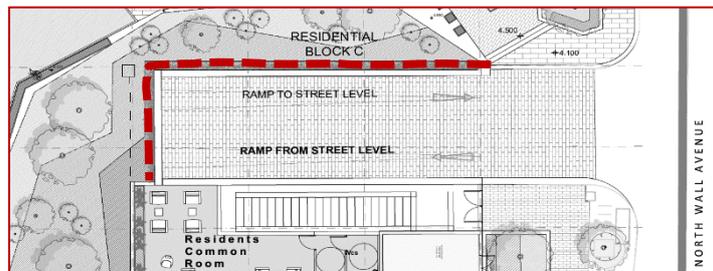
*Summary:* Unprotected height hazard at the basement carpark access could lead to serious personal injury or fatal incidents.

Ground level edge protection has not been indicated adjacent to the basement carpark ramp. There is a risk that pedestrians at ground level, especially small children, may inadvertently fall onto the ramp below and suffer serious or fatal injuries.

Provide edge protection at locations where there is a level difference between adjacent platforms.

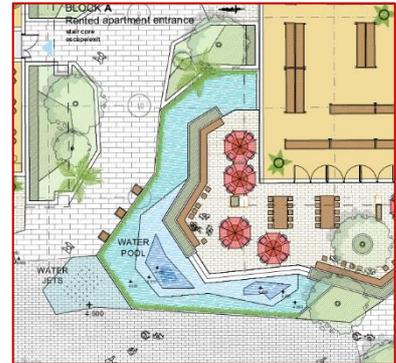
Summary: *Unprotected water feature could lead to serious personal injury, or drowning.*

It is unclear if any edge protection is proposed at the water feature near Apartment Block A. The absence of edge protection at the water feature may increase the risk of pedestrians, particularly small children, falling into the water feature and suffering serious injury, or drowning.

Suitable edge protection measures should be provided at the water feature.

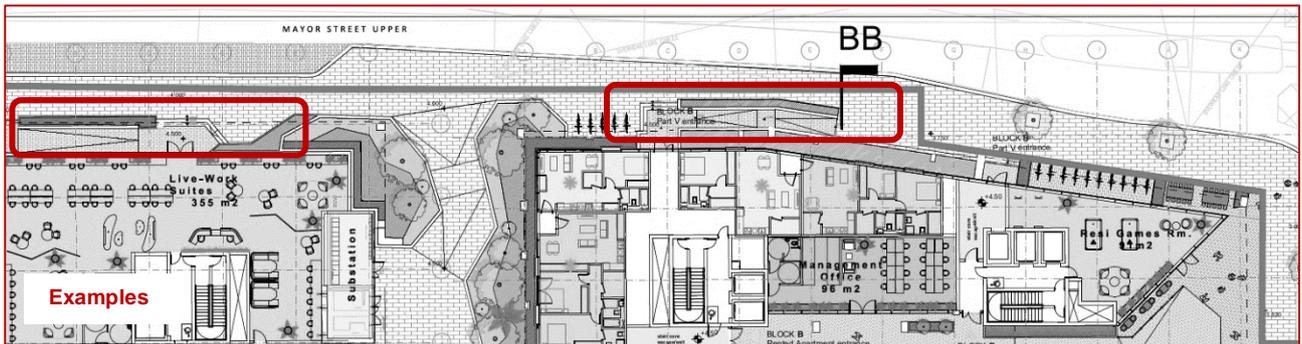
Summary: *Hazard tactile paving has not been indicated at the top and bottom of steps and ramps within the development.*

Steps and ramps have been indicated throughout the development, for example, at the entrance to Apartment Block A on Mayor Street Upper. Hazard tactile paving has not been indicated at the top or bottom of these steps/ramps. This could lead to visually impaired pedestrians being insufficiently aware of the vertical hazard ahead, resulting in them inadvertently entering the steps/ramps resulting in trips, falls and serious injuries.

Hazard (i.e. corduroy) tactile paving should be provided at the top and bottom of steps and ramps.

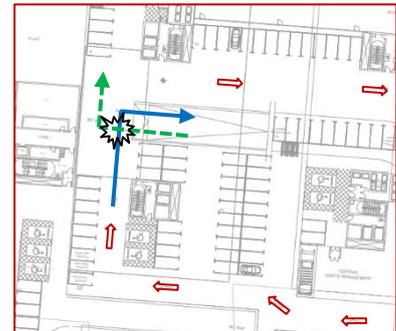
*Summary: Direction of one-way system on Basement Level -3 may increase risk of conflicts at ramp access, leading to side-on and material damage collisions.*

The clockwise direction of the one-way system indicated on Basement Level -3 will require vehicles entering/exiting the ramp to cross at the ramp access. This crossing manoeuvre may increase the risk of side-on and material damage collisions.

The direction of the one-way system should be reversed, such that traffic travels in an anti-clockwise direction, thus negating the need for vehicles to cross at the ramp access.

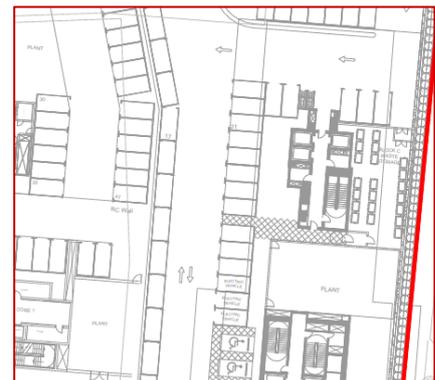
*Summary: Basement carpark do not include clearly designated pedestrian routes, which may increase the risk of vehicle/pedestrian collisions.*

Basement carpark layouts do not indicate pedestrian walkways or designated pedestrian routes. As a result, pedestrians may unintentionally choose routes that bring them into direct conflict with vehicles, particularly in locations where inter-visibility is reduced by structural columns and walls.

Similarly, the basement carpark layouts indicate that pedestrians travelling from the stairwell/elevator will need to pass between narrow gaps in the parking arrangement, where inter-visibility between drivers and pedestrians will be significantly reduced.

Insufficient inter-visibility between drivers and pedestrians may increase the risk of vehicle/pedestrian collisions.

Provide clear pedestrian routes within the basement carpark and ensure adequate inter-visibility between drivers and pedestrians on key pedestrian desire lines.

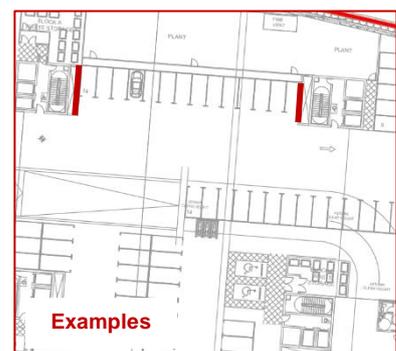
*Summary: Drivers exiting parking spaces adjacent to the basement walls will have restricted visibility, which may lead to side-on or vehicle/pedestrian collisions.*

Vehicles exiting from parking spaces immediately adjacent to the elevator/stairwell blocks will have restricted visibility towards approaching vehicles/pedestrians on the internal circulating lanes. This could result in low-speed side-on or vehicle/pedestrian collisions.

Remove parking spaces that are directly adjacent to the elevator/stairwell blocks.

Alternatively, use road markings to create a buffer zone that positions vehicles/pedestrians away from the elevator/stairwell block when travelling within the carpark.

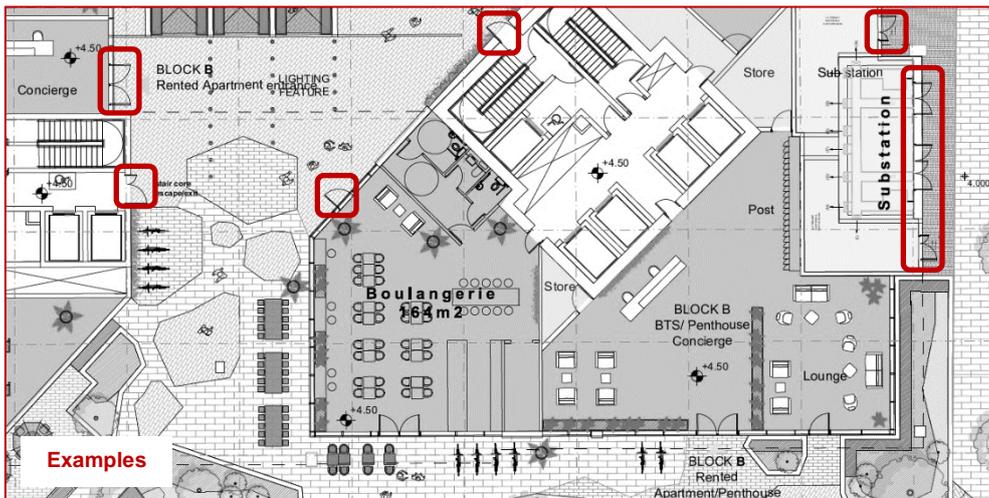
Summary: Doors opening into the footway may conflict with pedestrians and cyclists, leading to personal injury collisions.

A number of external doors associated with the development (e.g. substation onto the concourse near the northern extent of the development) are indicated as opening outwards. This arrangement can present a hazard to pedestrians/cyclists who may not anticipate a door opening into their path, leading to personal injury collisions, whilst also presenting difficulties for mobility-impaired road users.

Doors should open into the building so as not to obstruct or conflict with pedestrians and cyclists on the footway.

However, this recommendation should not be adopted should it directly contradict building and fire safety regulations. Should building and fire regulations require the doors to open into the footway (i.e. open outwards), measures should be provided to alert pedestrians and cyclists.

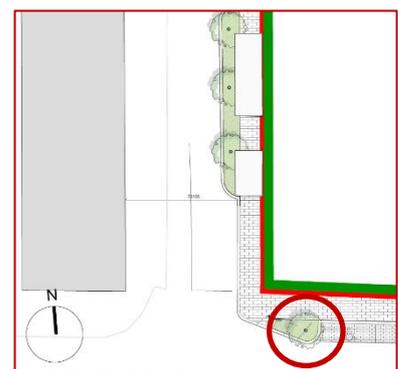
Summary: Visibility exiting Castleforbes Road may be restricted by planting indicated within the footpath, which could lead to side-on collisions.

Planting has been indicated within the North Wall Quay footpath at its junction with Castleforbes Road. The planting/tree could restrict a driver's visibility towards approaching vehicles when stationary at the stop line. This could result in drivers entering North Wall Quay ahead of oncoming vehicles when it is unsafe to do so, leading to side-on collisions.

Ensure the planting of trees within the scheme does not impede a driver's visibility when exiting side roads.

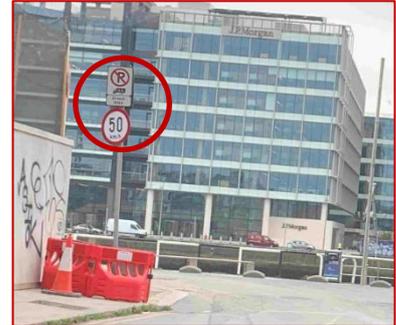
*Summary: The existing junction control at the Castleforbes Road/North Wall Quay T-junction is not clear and may lead to side-on or overshoot collisions.*

The existing junction control at the Castleforbes Road/North Wall Quay T-junction is not clear and is absent from the design drawings provided to the Audit Team.

This could lead to driver confusion and potentially to the risk of drivers failing to come to a complete stop at the junction, resulting in them exiting Castleforbes Road when it is unsafe to do so. This could increase the risk of side-on and overshoot collisions.

A Stop control junction should be provided at the Castleforbes Road/North Wall Quay T-junction with associated signs/markings.

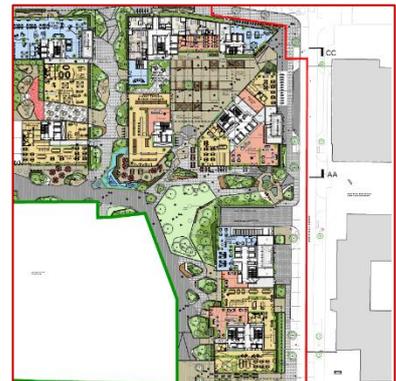
*Summary: It is unclear if the scheme's concourse/central pedestrian plaza proposes a sufficient level of tonal contrast between safe zones and shared surfaces where the movement of cyclists is promoted. This could lead to pedestrian/cyclist collisions.*

The location of the elevators to the underground bicycle parking area, and the position of bicycle parking within these concourse areas on the ground floor suggest that the internal concourse areas and the external paths around the development are to be shared paths between pedestrians and cyclists.

However, no tactile paving at the transition between the shared use paths/concourses and the external road environment, which is a segregated arrangement, have been indicated.

The absence of tactile guidance surfaces and colour contrast may lead to visually impaired pedestrians becoming confused, and unintentionally straying into shared areas where cyclists are present. This could lead to pedestrian/cyclist collisions.

Ensure that vulnerable road users, in particular the visually impaired, are adequately informed of when they are expected to share space with cyclists.

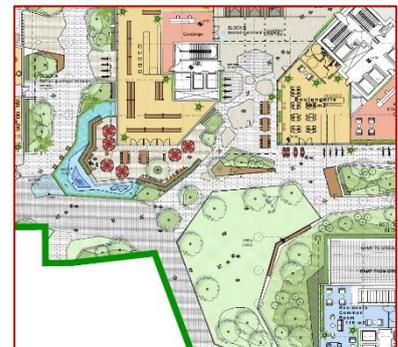
Visually impaired pedestrians may find it difficult to navigate the public areas on the ground floor of the development, as the pavement layout and pallet of materials may not support a clear pedestrian corridor to key entrances and amenities.

The absence of tactile guidance surfaces and colour contrast may lead difficulties for visually impaired pedestrians independently navigating these spaces.

Ensure that visually impaired pedestrians are able to independently navigate the pedestrian concourse through the application of carefully considered pavement materials, colours, and tactile paving.

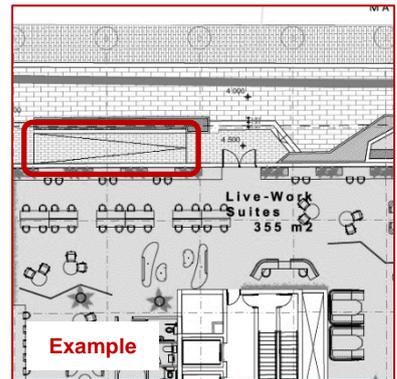
Footway gradients within the development are unclear and could lead to user discomfort if long ramps with gradients steeper than 1:20 are provided.

Ensure ramps are constructed in accordance with the National Disability Authority's guidance publication "Building for Everyone (External Environment and Approach)".

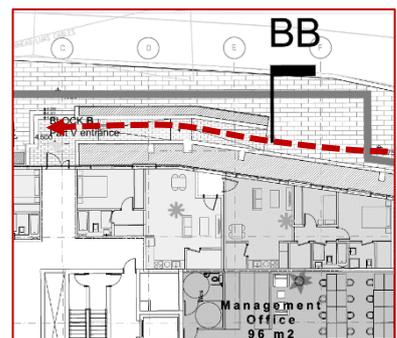
Visually impaired pedestrians walking in a westbound direction on Mayor Street Upper may unintentionally continue onto the pedestrian basement access ramp, which has no through route, and become disoriented and confused.

Provide corduroy tactile paving at the start of the pedestrian basement access ramp, and colour contrast, to better advise and direct visually impaired pedestrians using Mayor Street Upper.

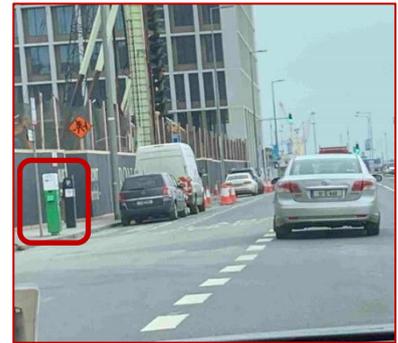
The removal of this facility may inconvenience members of the general public who may currently charge their vehicle at this location.

The EV parking space should be retained on North Wall Quay or moved to a nearby location on North Wall Quay, Castleforbes Road or North Wall Avenue.
