Strategic Housing Development at  
North Wall Quay, Co. Dublin

Quality Audit

**Document Ref:** P20-096-UQA-GEN-RP-001

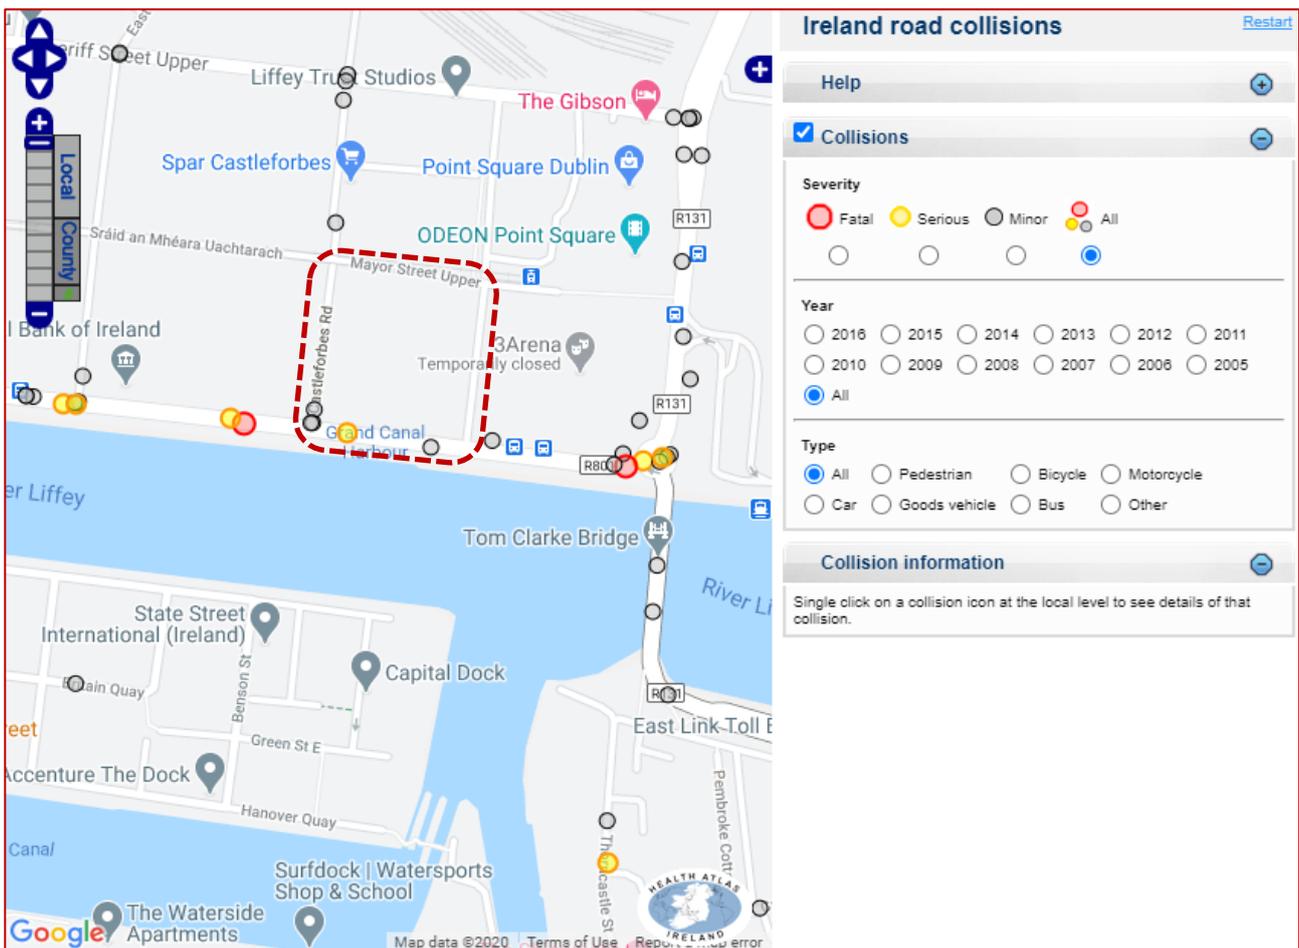
FIGURE 2-2 COLLISIONS RECORDED IN THE VICINITY OF THE PROPOSED DEVELOPMENT

The level of detail provided on the RSA collision database does not permit a forensic assessment of the collisions noted above. However, the collision records, and their distribution over time, do not highlight a collision cluster or pattern near the proposed development.

**Note:** The Audit Team were made aware of a Fatal collision involving a cyclist that occurred in September 2020. However, the absence of formal collision data, as collected and verified by An Garda Síochána/the Road Safety Authority precludes further investigation as part of this audit.

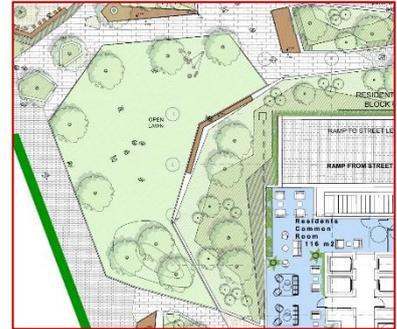
#### 4.2.3 Issue

Footway gradients within the development are unclear and could lead to user discomfort if long ramps with gradients steeper than 1:20 are provided.
